Aviation Investigation Final Report

Location:	Broomfield, Colorado	Incident Number:	DCA21FA085
Date & Time:	February 20, 2021, 13:09 Local	Registration:	N772UA
Aircraft:	Boeing 777-222	Aircraft Damage:	Minor
Defining Event:	Powerplant sys/comp malf/fail	Injuries:	239 None
Flight Conducted Under:	Part 121: Air carrier - Scheduled

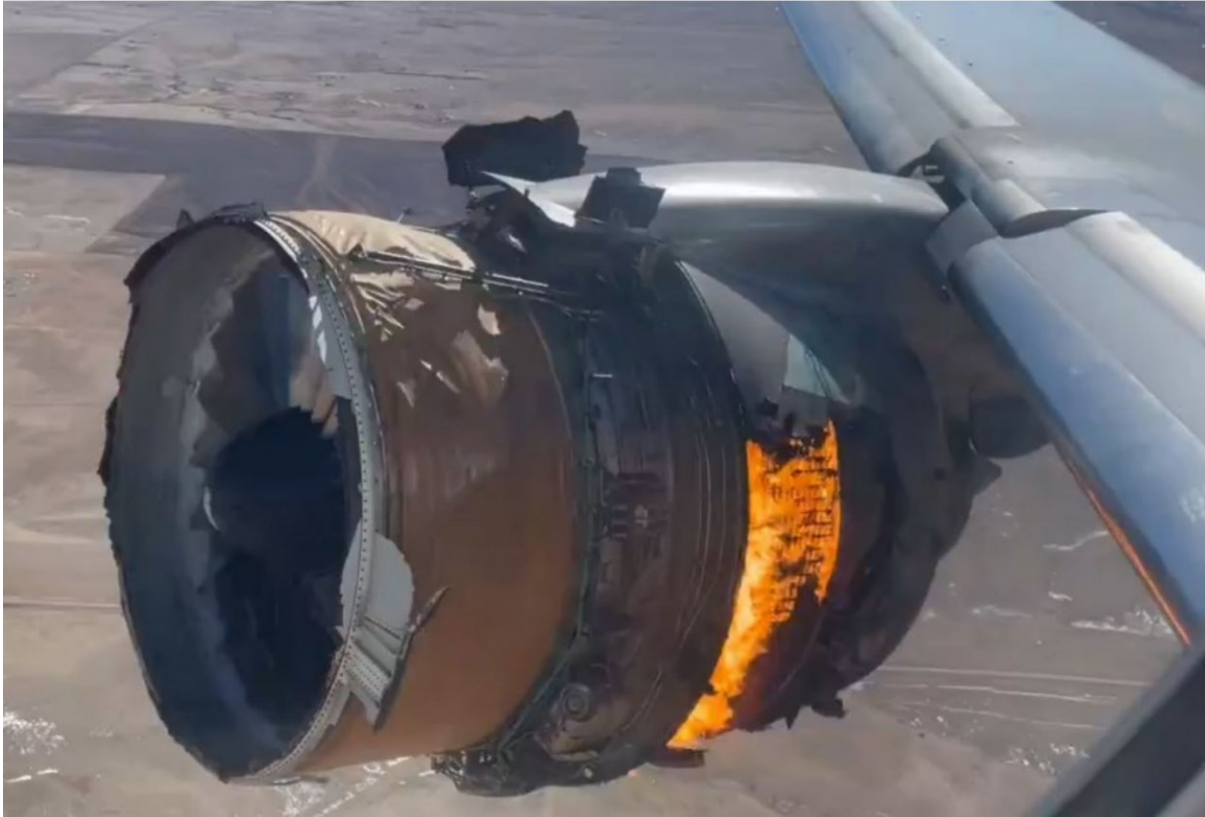
The flight crew declared an emergency with air traffic control (ATC) and completed multiple checklists, including the engine fire checklist. As part of the engine fire checklist, the crew discharged both right engine fire extinguishing bottles; however, the engine fire warning continued to display on the EICAS until shortly before landing. The crew landed the airplane on runway 26 at DEN at 1328 and the airplane was met by aircraft rescue and firefighting (ARFF), which applied water and foaming agent to the right engine for about 40 minutes. The airplane was then towed off the runway, where the passengers disembarked via air stairs and were bussed to the terminal. Figure 1 below, a still image captured from in-flight video recorded by a passenger, shows the damage to the engine nacelle as well as the under-cowl fire about 11 minutes after the fan blade separation.

Figure 1. Still image from passenger in-flight video showing engine nacelle damage and under-cowl fire about 11 minutes after fan blade separation (Courtesy Boeing via YouTube).

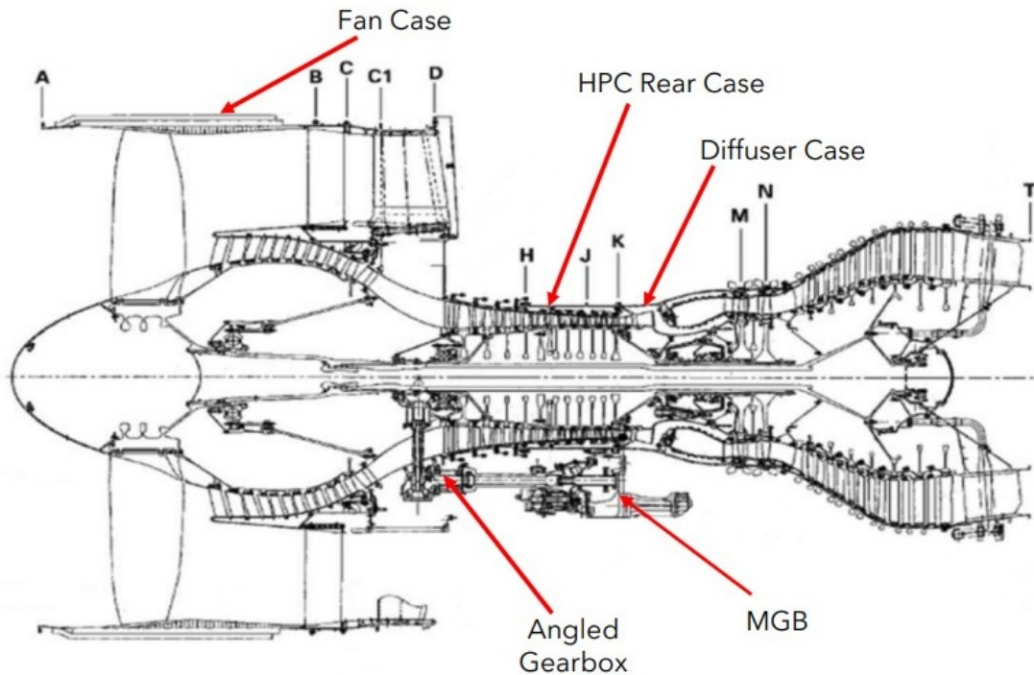
Figure 3. PW4000 112-inch significant engine flanges (Source: Pratt & Whitney)

The "K" flange joins the HPC rear case with the diffuser case, which contains the internal hot gases of the operating engine (refer to Figure 3 for location of the "K" flange). Examination revealed that the "K" flange was separated, and all the fastening bolts had failed. Most of the bolt holes were empty; in the locations where bolt remnants were found, the bolts were sheared in the plane of the aft face of the forward flange. Some of the fractured bolts or nut ends were retained by case features. At the location of the "K" flange near the HPC discharge plane, the compressed air temperature exceeds 1,000°F. In the event of a "K" flange separation, the leaking high temperature HPC discharge gas could provide an ignition source of any fuel present in the nacelle.

Pratt & Whitney is evaluating actions to improve the strength of the "K" flange and expects hardware to be available in 2025.

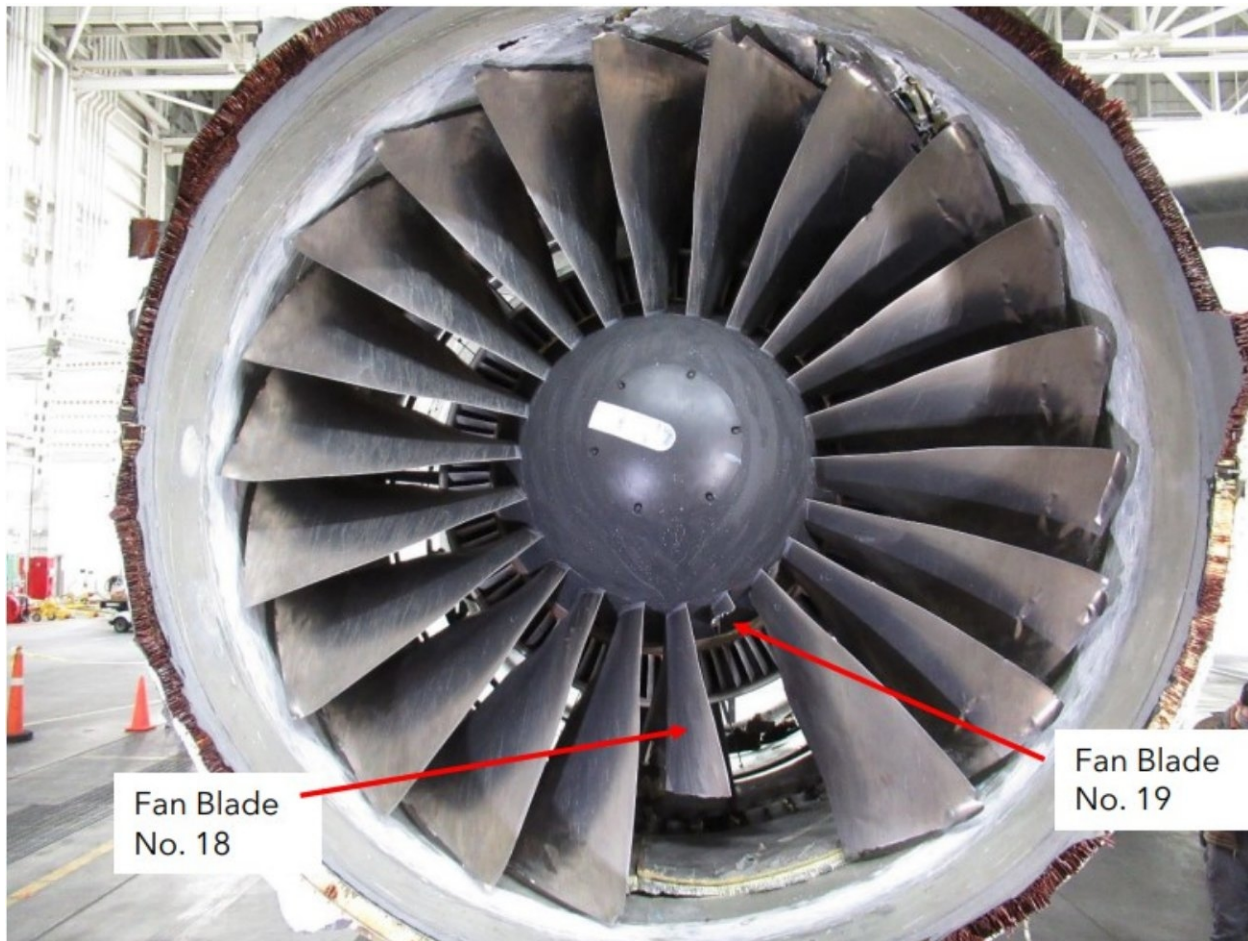
Examination of the right engine revealed that one fan blade, identified as No. 19, was fractured transversely across the chord of the airfoil at the plane of the fan hub fairing, known as a full-span blade separation, or fan blade out (FBO). A piece of fan blade, which measured about 13 inches long by 6 inches wide, was recovered with the debris that had fallen from the airplane during flight and was identified with the last five digits of the fractured blade serial number.

The adjacent fan blade (No. 18) was fractured across the airfoil about 25 inches above the fairing and displayed evidence of overload failure. All of the other fan blades were intact, but

displayed varying degrees of impact damage to the airfoils, with the tips bent and curled opposite the direction of rotation. (see figure 5.)

Figure 5. Fan blades as viewed from front, showing the two fractured blades and damage to the remaining intact blades.

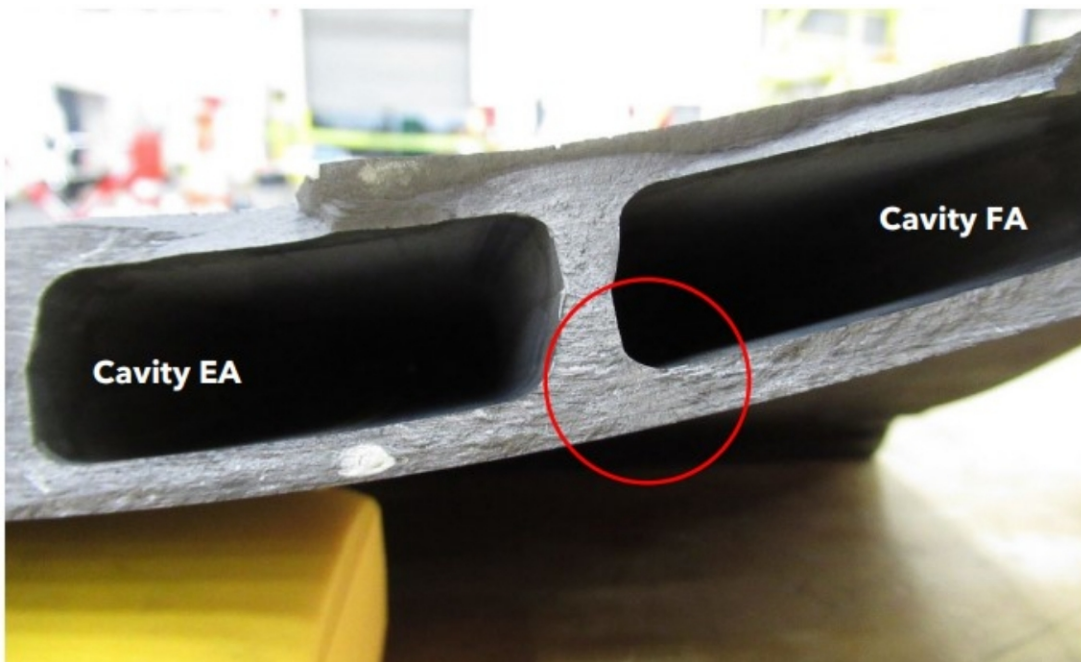
Metallurgical examination of the fractured blade was performed at the P&W Materials Laboratory under NTSB supervision. The examination revealed a fatigue crack that initiated internally about 6.6 inches above the root on the surface of an internal radius in a cavity of the hollow core fan blade. (see figure 6.) The fracture surface showed evidence of an estimated 3,150 cycles of stable low-cycle fatigue growth between 0.063 inch to 0.199 inch from the fatigue origin.

In addition to the primary fracture, multiple fatigue cracks were identified in the flowpath and midspan of the fractured blade. These secondary fatigue cracks had origins at the internal cavity surfaces, and many of the cracks exhibited multiple origins, consistent with the primary fracture. The largest of the secondary cracks had a maximum crack depth of 0.065 inch.

Figure 6. Closeup of fan blade No. 19 fracture surface and fatigue evidence.

Examination of the crack that led to the failure of the blade revealed a discontinuity in a local tight radius in the internal blade geometry that had been introduced during the machining and manufacturing process. A P&W technical review of the discontinuity estimated a local steady stress increase of 30% at the location, reducing the fatigue life by 50%.

Metallurgical and chemical characterization revealed that the surfaces of the internal cavities were contaminated with carbon that had diffused into the parent material. According to P&W engineers, carbon contamination of titanium can cause decreased fatigue resistance capability. It was observed that the carbon surface contamination was not present in the cavities of the blade that are sealed off during the diffusion bonding process, indicating that the contamination was introduced after the diffusion bonding process.

Following this event, Pratt & Whitney performed an immediate TAI inspection of the entire fleet before the next flight and issued a service bulletin introducing ultrasonic testing (UT) blade inspections to occur both immediately and at regular intervals. Additionally, the frequency of required TAI inspections was increased from every 6,500 cycles to every 1,000 cycles. The increased inspection interval and the immediate TAI inspection were made mandatory on April 15, 2022, when the FAA issued AD 2022-06-09. Additionally, the new UT inspection that was developed by Pratt & Whitney for the flowpath and midspan areas has shown a capability to detect small cracks that are below the threshold of detectability for the TAI inspection. The blades are now inspected by UT every 275 cycles.
