FATIGUE FAILURE OF THE DE HAVILLAND COMET I

P. A. WITHEY*

Abstract—The de Havilland Comet I entered service in 1952, and became the first commercial airliner to be powered by jet engines. It was introduced as the flagship aircraft on the routes of the British Overseas Airways Corporation, and was hailed as a triumph of British engineering. However there were a number of accidents involving this aircraft, culminating, in 1954, in the loss of two aircraft in similar circumstances. These were Comet G-ALYP near Elba, and Comet G-ALYY near Naples. A Court of Inquiry was convened, and the task of discovering the cause of these accidents was given to the Royal Aircraft Establishment at Farnborough. The investigation explored a number of avenues, and finally gave structural failure of the pressure cabin brought about by fatigue as the cause of the accidents. The use of fracture mechanics methods not used in 1954 has enabled the analysis of these fatigue cracks to be made, and the initial defect size has been estimated to be approximately $100\ \mu\text{m}$ in the case of G-ALYP. This is not incompatible with the manufacturing techniques of the time, and information regarding cracks in th

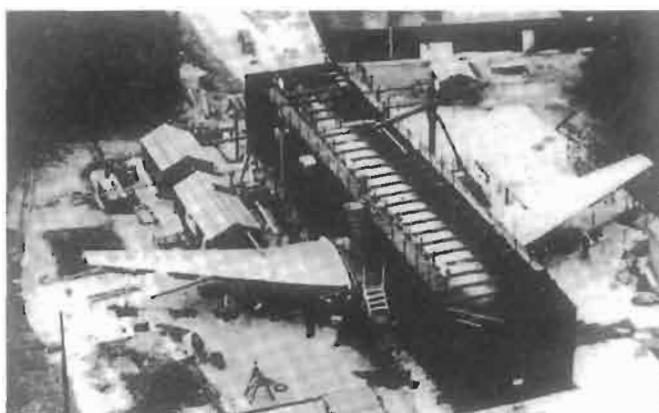
Fig. 2. Aerial view of Comet G-ALYU in testing tank. Crown Copyright. Reproduced with the permission of the Controller of HMSO.

This arrangement enabled the loads associated with a flight to be applied in 5 min. This accelerated testing showed a severe weakness to fatigue crack growth in the aircraft skin around cut-outs such as windows and escape hatches. The skin of Yoke Uncle had undergone 3057 flight cycles [1] (1221 actual and 1836 simulated) before a fatigue crack grew to failure from a rivet hole near the forward port escape hatch (Fig. 3). The crack length before final failure was less than 2 mm in this accelerated test [2]. This failure was then repaired, and the simulated flight testing continued. Cracks were observed around a number of other windows and in the wings, and their growth monitored. This programme of tests was only stopped after 5546 pressurizations, when a fatigue crack grew to failure from the port number 7 window, and removed a 4.5 m section of cabin wall. It was concluded [2] that Comet Yoke Uncle, had it continued to fly, would have suffered cabin failure at around 9000 h. In addition to the cabin pressurization simulation, there were also proving tests conducted every 1000 flights to a pressure of 11 psi (76 kPa) to simulate those conducted by the operators or designers from time to time [2] to test the structural integrity of the cabin.

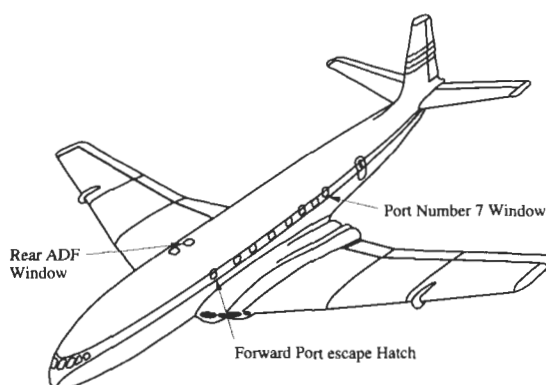
Fig. 3. The main failure sites on Comets G-ALYP and G-ALYU.

Cracks were known to be present in the aircraft upon manufacture, and there was an approved technique for identifying such defects and "locating" them by drilling the end of the crack with a $\frac{1}{16}$ in. (1.6 mm) drill [1]. In most cases, the crack was seen not to extend beyond the location hole, and this was assumed to be adequate security against further crack growth. In fact, there was a "located" crack near the forward port corner of the rear ADF (automatic direction finding) window (Fig. 3) on Yoke Peter, which did not grow beyond the locating hole until the final failure of the cabin.

The failure of Yoke Peter was deduced to be a fatigue crack near the starboard rear corner of the rear ADF window (Fig. 4). This crack emanated from a 10 mm diameter bolthole, and propagated to failure after unexpectedly few pressure cycles of the cabin. This bolthole in such a highly stressed

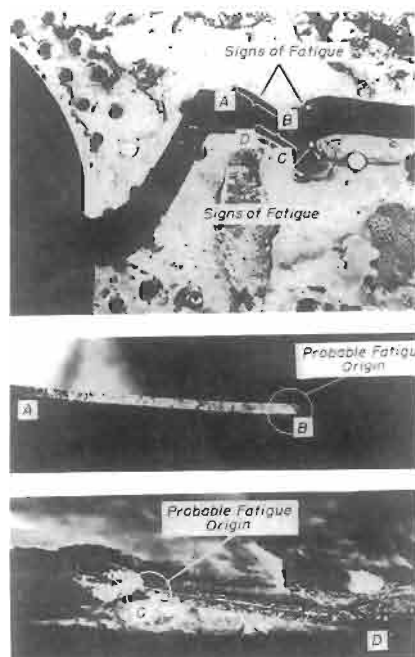
Fig. 4. Close-up views of the failure in the skin of Comet G-ALYP. Crown Copyright. Reproduced with the permission of the Controller of HMSO.

area was recognized as a prime site for fatigue failure initiation, and de Havilland subsequently redesigned the windows and increased the thickness of the skin in these areas to prevent this occurring on later Comet aircraft. The stress around a cut-out was shown to be over 3 times the remote stress due to cabin pressurization both experimentally [2] and theoretically [3]. Using the $S-N$ data available at the time, it was possible to explain the shortened fatigue life.

The bolthole which was the origin of the failure in Yoke Peter was over 50 mm from the ADF window (Fig. 4), and the stress in this area was significantly below the maximum stress at the ADF window itself. In fact, as part of the RAE investigation, strain gauges were placed around areas such as the ADF windows on Yoke Uncle to examine the stresses in this area. The stress in the vicinity of the bolthole was calculated to be around 70 MPa, compared to 315 MPa around the edge of the windows. This stress is reasonably close to that expected as a general level for a pressurized cylinder of 1.6 m radius, and a thickness of 1.42 mm. This thickness is derived from the 0.71 mm (22 gauge) skin and 0.71 mm thick doubler plate around the ADF window. Although the crack grew principally towards the ADF window, the stresses in this area were shown, using strain gauges, not to vary much, and the crack was only 25 mm long when failure occurred [2].

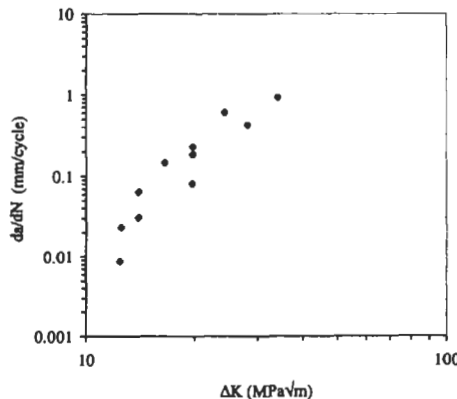
This plot gives a value for A of 9.6×10^{-7} for da/dN measured in mm/cycle, and a Paris exponent,

Fig. 5. Fatigue crack growth of the Comet I fuselage.

m , of 4.0. The crack growth rate is much faster than for subsequent aluminium alloys, but it is unclear whether this is due to the alloy itself, the application, or the water environment of the test. The consequences of the water environment of the tank test were addressed by Atkinson *et al.* [5] at the time of the tests, and it was felt that a cabin skin would be cycled through wet and dry periods during service (outside due to the weather and inside due to condensation), and this cycling may be more damaging than the environment of a tank test. The degraded environmental performance in aluminium alloys in aerospace applications has also been noted by Barter *et al.* [6].
